Petrographic Analysis of Portland Cement Concrete Cores from Pease Air National Guard Base, New Hampshire

E. Rae Reed-Gore, Kyle L. Klaus, and Robert D. Moser

November 2016

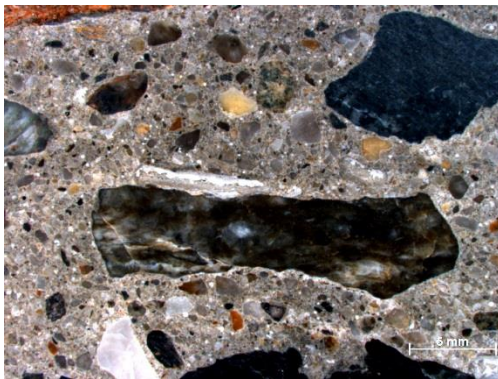
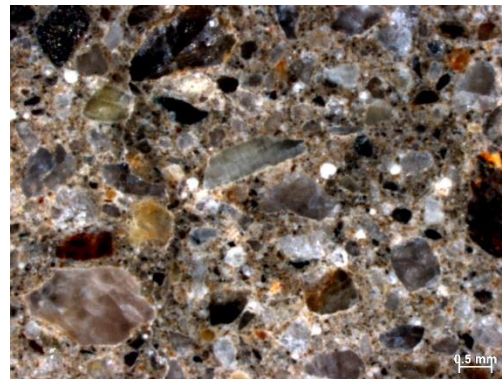
Figure 9. Low and high magnification photomicrographs of 160159-13 – T03A, (a) very little carbonation staining at the surface, (b) iron staining within around coarse aggregate, (c) highly fractured coarse aggregate with what appears to be ASR gel infilling voids and around deboned surface, (d) view of cement and fine aggregate, with infilling of voids and iron staining.
